INDOOR AIR QUALITY ASSESSMENT

**Emerson School Wing
100 Mechanic Street
Bolton, MA 01740**

Prepared by:
Massachusetts Department of Public Health
Center for Environmental Health
Emergency Response/Indoor Air Quality Program
October 2006

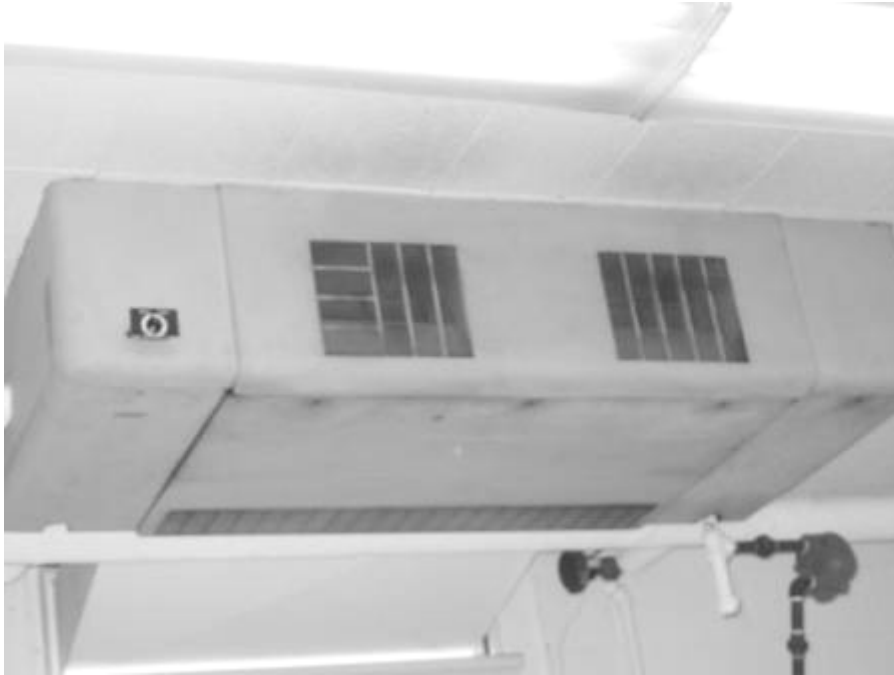
Picture 1

Mechanical ventilation in the 1972 portion of the building is provided by rooftop air-handling units (AHUs). Fresh air is distributed via ceiling-mounted air diffusers. Air is ducted back to AHUs via ceiling-mounted return vents. Fresh air in the 1952 wing classrooms is supplied by unit ventilator (univent) systems (Picture 1). A univent is designed to draw air from outdoors through a fresh air intake located on the exterior wall of the building (Picture 2) and return air through an air intake located at the base of the unit ([Figure 1](#)). Fresh and return air are mixed, filtered, heated and provided to classrooms

through an air diffuser located in the top of the unit. Many univents were found to be off or operating weakly at the time of the assessment. Please note, univents appeared to be original to the building (over 50 years old). Therefore, repair/replacement of parts may be difficult for units of this age.

Classroom univent, circa 1950s model

2. Examine each univent for function to ascertain if an adequate air supply exists for each room. Check fresh air intakes for repair and increase the percentage of fresh air intake if necessary.

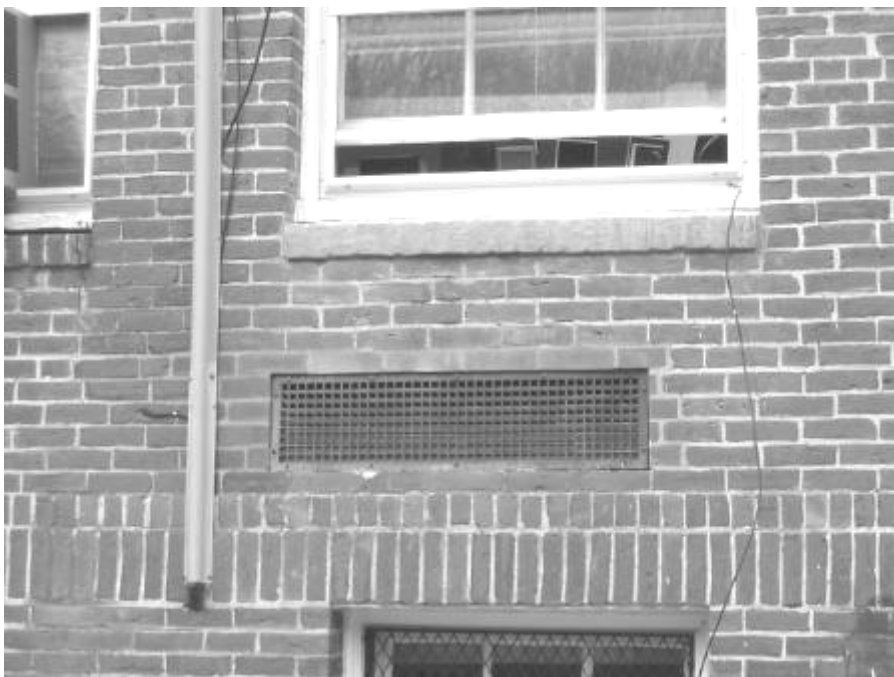
Picture 2

Univent fresh air intake

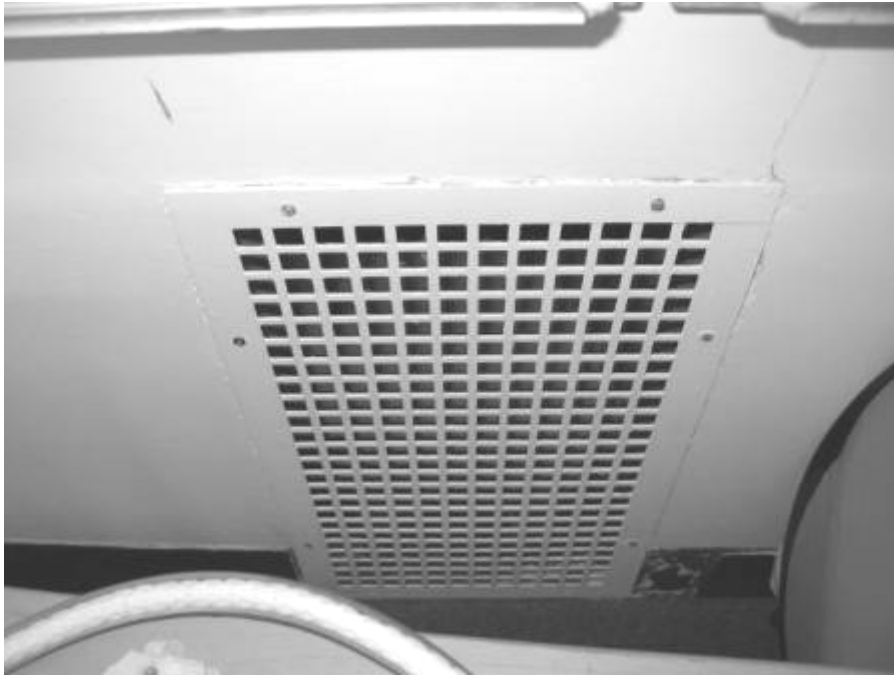
Picture 3

Exhaust ventilation in classrooms is provided by ducted, grated wall vents powered by rooftop motors. At the time of the assessment, some exhaust vents were not operating, which can indicate they were deactivated or inoperable. In addition, a number of vents were obstructed by desks, bookcases and other items (Picture 3). In order for univents and exhaust vents to function properly, they must be activated and remain free of obstructions.

Wall-mounted exhaust vent behind desk

3. Reactivate exhaust ventilation, make repairs as necessary.
 4. Remove all blockages from univents and exhaust vents to ensure adequate airflow.
 5. Use openable windows/exterior doors in conjunction with classroom univents and exhaust vents to increase air exchange. Care should be taken to ensure windows and doors are properly closed at night and weekends to avoid the freezing of pipes and potential flooding.

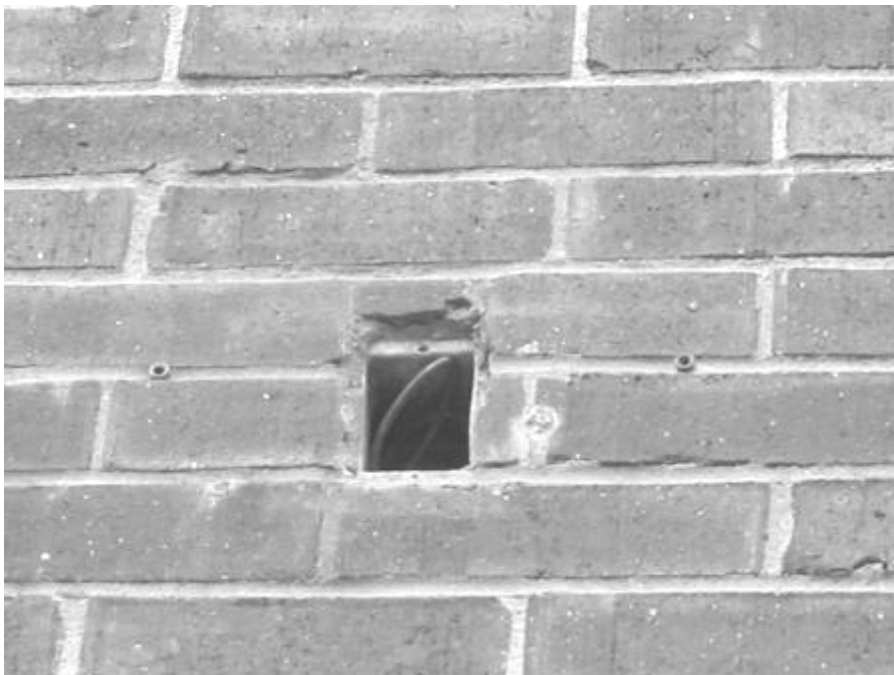
Picture 4

Plants were observed to be growing against the foundation walls. The growth of roots against exterior walls can bring moisture in contact with the foundation. Plant roots can eventually penetrate, leading to cracks and/or fissures in the sublevel foundation. CEH staff also observed an open electrical box on the exterior of the building, which should be sealed to prevent water penetration and bird/insect habitation (Picture 4).

Open electrical box

11. Remove plants from the foundation wall junction around the perimeter of the building. Seal the junction with an appropriate sealant.
12. Relocate or consider reducing the amount of materials stored in classrooms to allow for more thorough cleaning. Clean items regularly with a wet cloth or sponge to prevent excessive dust build-up.

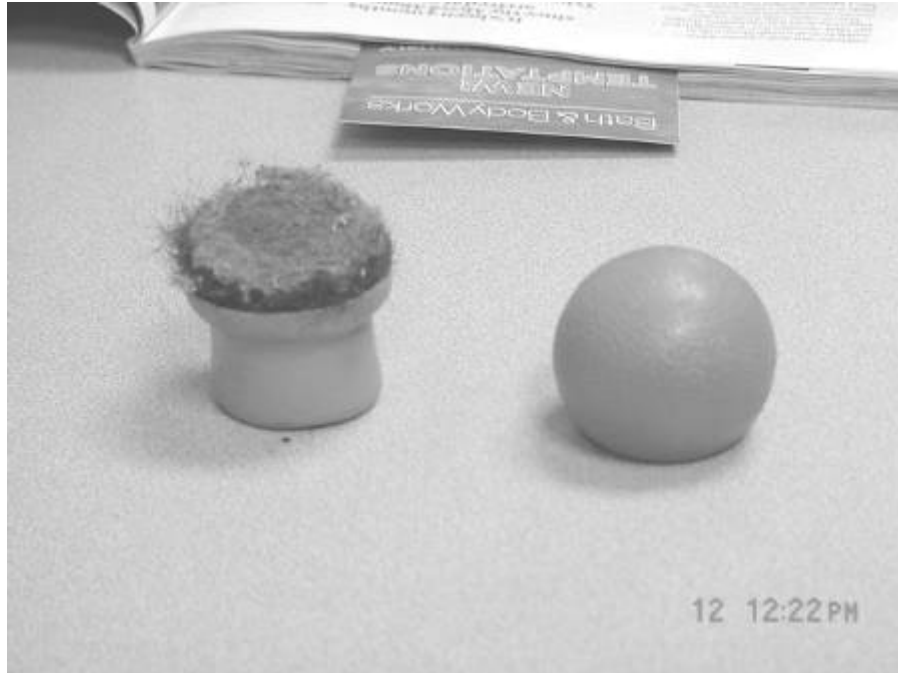
Picture 5

Lastly, in an effort to reduce noise from sliding chairs, tennis balls had been sliced open and placed on chair legs. Tennis balls are made of a number of materials that are a source of respiratory irritants. Constant wearing of tennis balls can produce fibers and off gas VOCs. Tennis balls are made with a natural rubber latex bladder, which becomes abraded when used as a chair leg pad. Use of tennis balls in this manner may introduce latex dust into the school environment. Some individuals are highly allergic to latex (e.g., spina bifida patients) (SBAA, 2001). It is recommended that the use of materials containing latex be limited in buildings to reduce the likelihood of symptoms in sensitive

individuals (NIOSH, 1997). A question and answer sheet concerning latex allergy is attached as [Appendix B](#) (NIOSH, 1998). Consider replacing tennis balls with alternative glides (Picture 5).

Alternative “glides” for chair legs that can be used in place of tennis balls
